FABRICATION OF 1/3 SCALE
BORON/EPOXY BOOSTER THRUST STRUCTURE

Phase I Final Report

CR-119958

Advanced Composite Group
GRUMMAN AEROSPACE CORPORATION
Bethpage, New York 11714

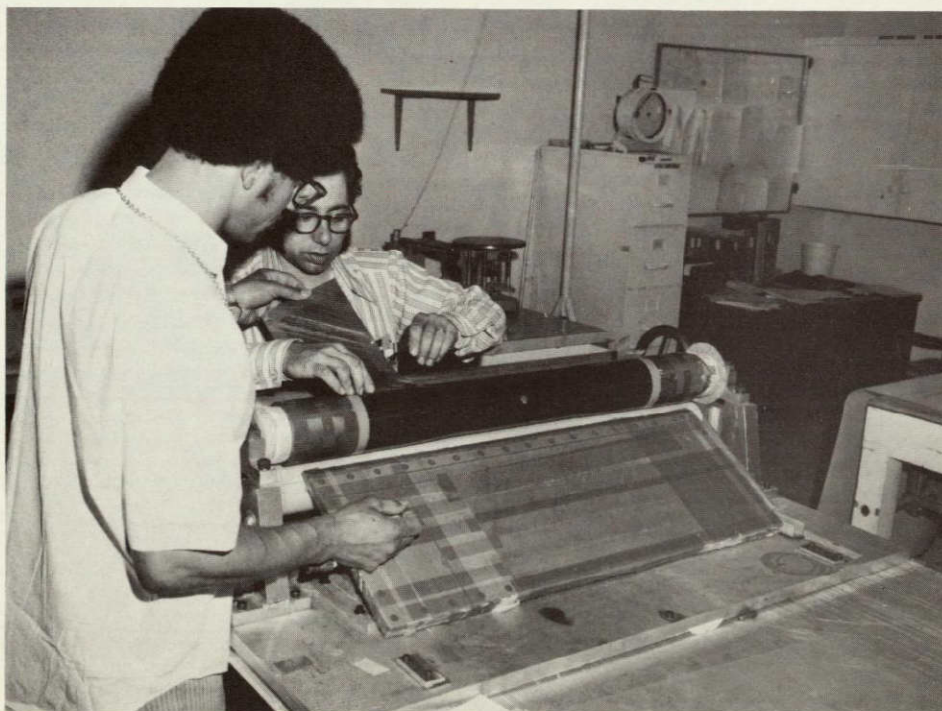
Figure 3-4 Tube Wrapping Machine

The tube fabrication procedure utilized with the wrapping machine was:

- o Apply boron tape to the mylar layup template
- o Position the template on the wrapping machine and attach to the wind-up roller
- o Apply vacuum to the template

- o Wind template 2 turns on the wind-up roller
- o Position layup mandrel and adjust pressure roller
- o Turn wind-up roller until boron tape is fed between the layup mandrel and the pressure roller, transferring the tape to the mandrel

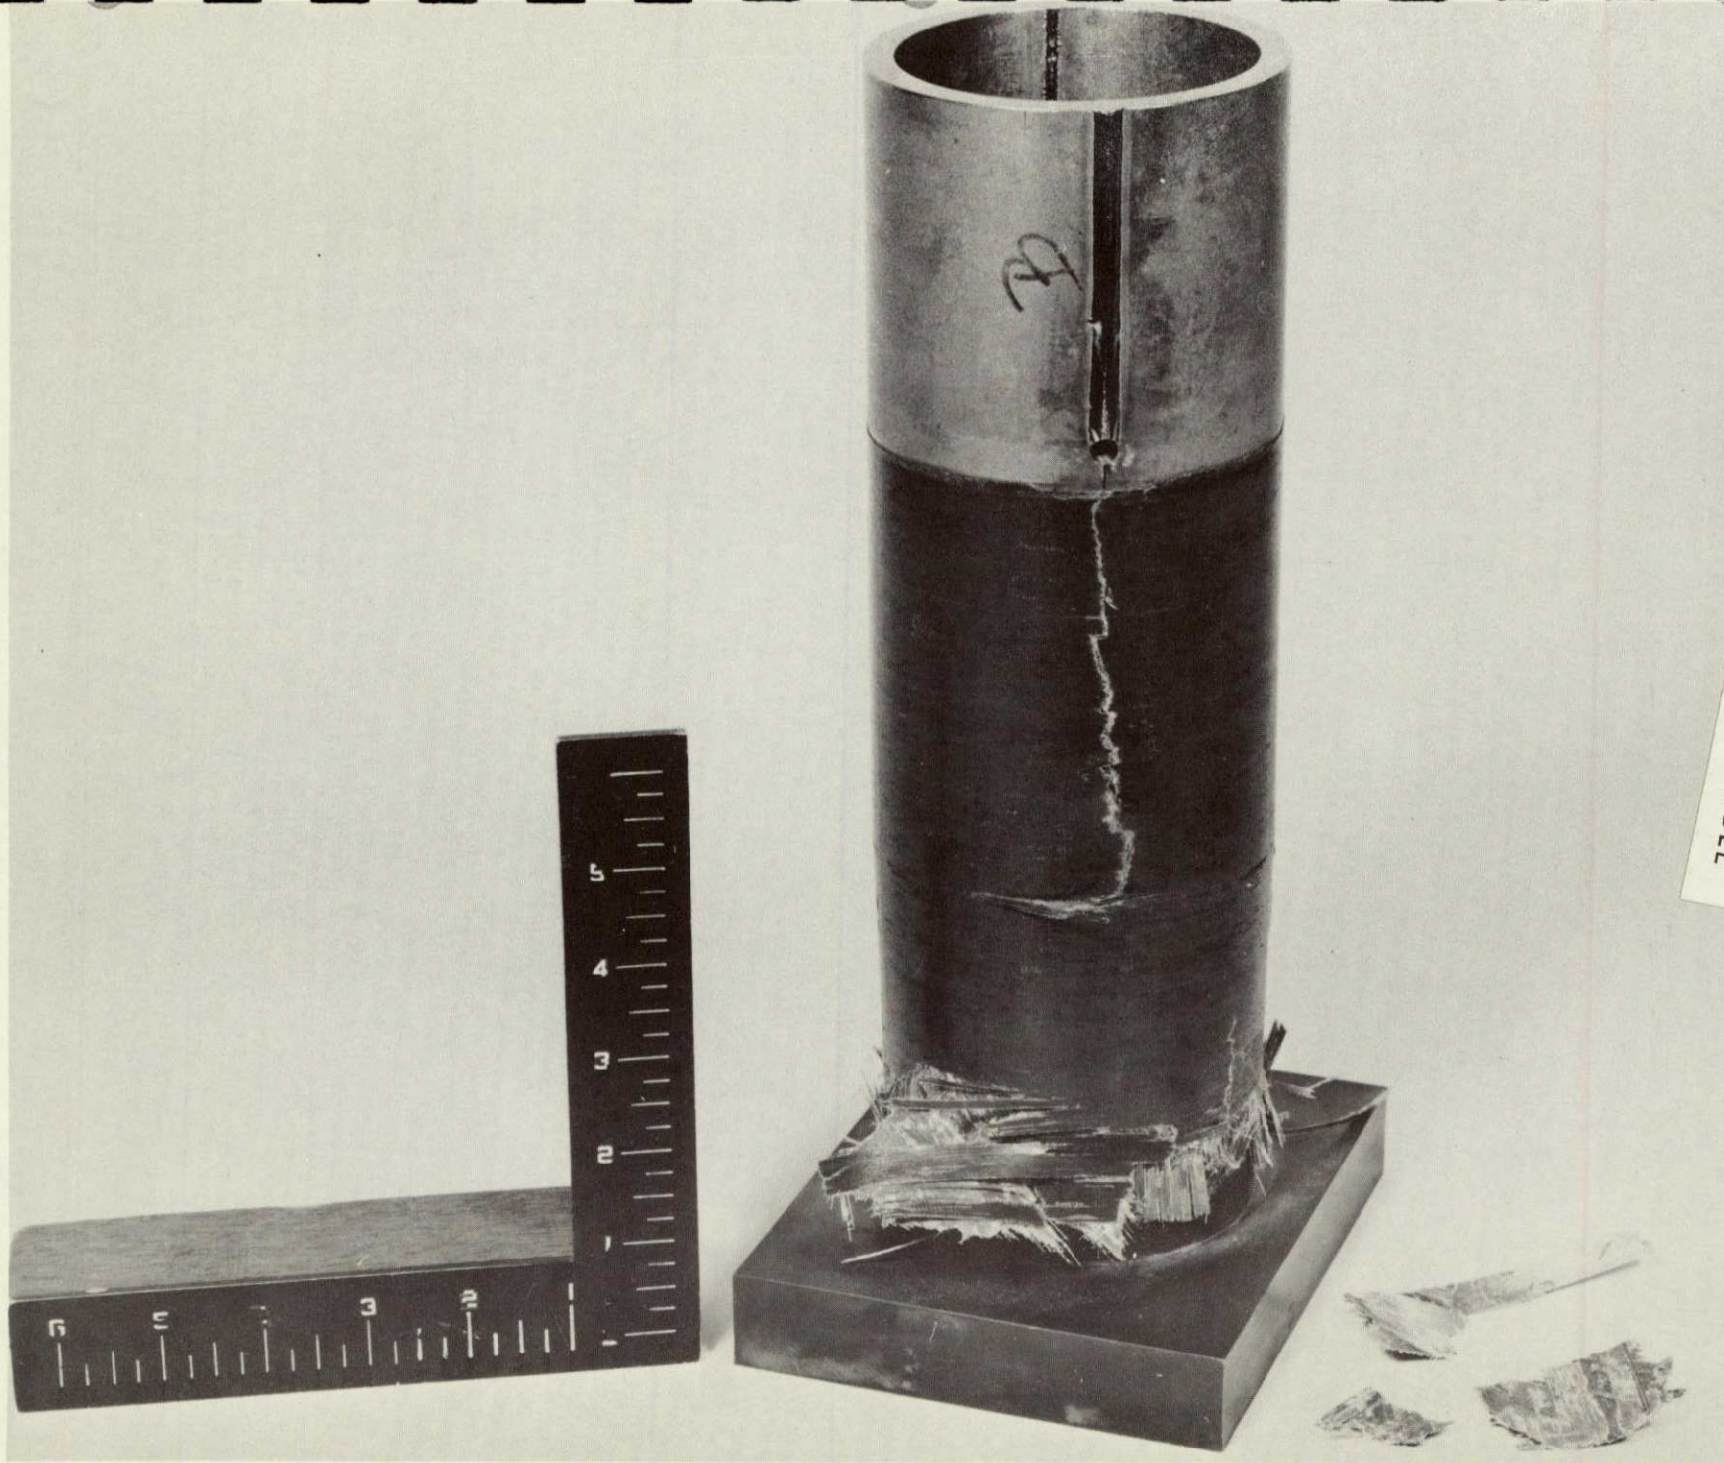
Figure 5-4 Side View of Failed Subelement Number 1

The first subelement specimen attained a load of $.7232 \times 10^6$ N (162,600 pounds, or 70 percent design ultimate load (DUL)) at which time a brooming type failure occurred at, and was contained in, the immediate vicinity of the potted end of the specimen. Figure 5-2 shows the specimen set up in the testing machine, prior to testing. After test the failed section of the B/Ep was removed and the specimen re-potted into a grooved steel end fixture. Figure 5-3 shows the specimen after rework and prior to retest. At an applied compressive load of $.7561 \times 10^6$ N (170,000 pounds, 74 percent DUL) failure occurred. Figure 5-4 shows the failed specimen. The primary failure was located in the B/Ep approximately 25.4 mm (1 inch) from the potted end, and extended circumferentially around the specimen.

Internal inspection of the specimen indicated that failure of the boron laminate did not extend through the entire thickness. There are two possible explanations for this failure:

- o The steel end fixture provided sufficient restraint to radial growth to induce bending stresses in the tube wall, which would relieve the compressive stress on the inner surface and increase the stress on the outer surface. In an effort to minimize the induced bending stress, the boron end of subelement number 2 was reinforced by a 90° fiberglass overwrap (identical to that used for the first test of this subelement).
- o The presence of some local circumferential delaminations, noted when the part was trimmed, approximately 4-6 plies in depth could reduce the effective thickness of the tube wall and thus the instability stress.

A second failure, extending over the B/Ep to titanium bonded joint at the juncture of the titanium fitting halves, was also noted. This failure originated at the initial splice transition point (load kick point) and progressed approximately 102 mm (4 inches) toward the titanium end. Again, internal inspection of the specimen revealed that the failure did not progress through the entire laminate thickness. The failure appeared to be tensile in nature, which prompted an investigation of induced hoop tension stresses at the load kick point. Results of the analysis showed that hoop stresses could have been developed which were sufficiently large to cause failure of the outer 90 degree ply. The following assumptions were made for this analysis:

A third observed failure, which was the disbonding of the boron from the internal last step of the splice, was noted after the specimen was removed from the test rig. This was probably a secondary failure resulting from the outer ply failures at the boron end.

In conclusion, it was felt that the cause of premature primary failure was not typical, and could be attributed to the presence of delaminations at the boron end of the tube, resulting from the previous test and the quality of the boron laminate.
